## ASSET INVESTIGATION REPORT

### TURNER STREET JETTY (JETTY No. 0620), AUGUSTA

| 0 | Asset Investigation Report | D. Schlueter | R. Kelly | M. Gannon | 27/06/23 |

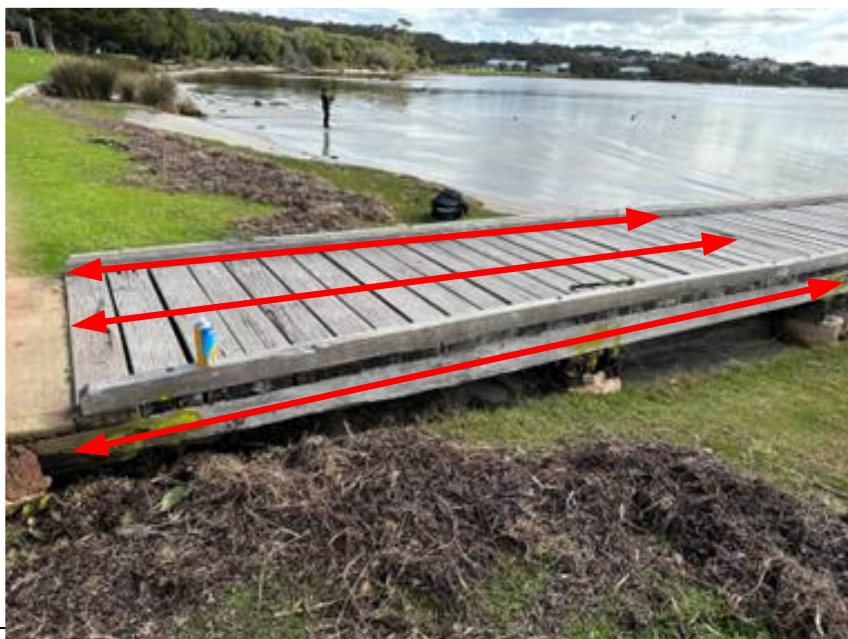
- 1). Replace the severely rotted stringers (3 off) located at the shore end of the jetty – see photo below. These stringers are partly in contact with the soil and the reason their severely rotted.

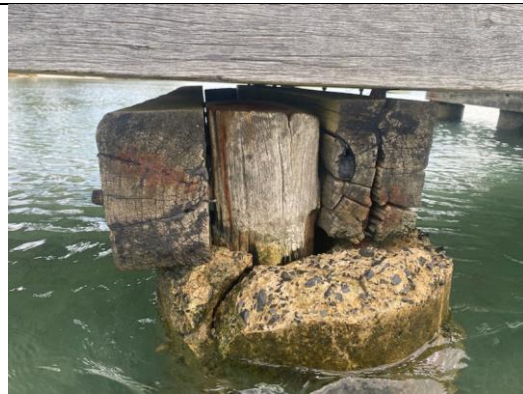
P1 Concrete Pot – extensive cracking & breakup

Remedial works that were previously recommended 21 months ago in order to extend the design life of the Jetty have not been carried out. Further severe and chronic degradation has now reached the level where there is no longer confidence in the continued structural integrity of the jetty. In conclusion, the jetty has reached the end of its service design life and in its current condition unsafe for continued use. It is recommended that the Jetty is immediately closed off for public use and demolished.

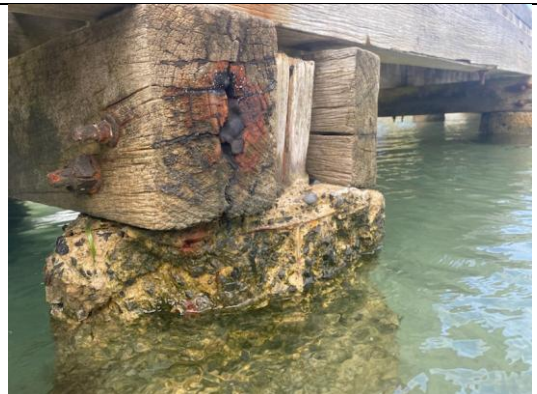
P2 Concrete Pot – extensive cracking & breakup

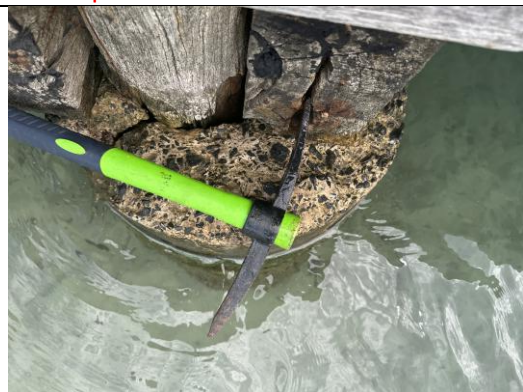
P3 Concrete Pot – extensive cracking & breakup

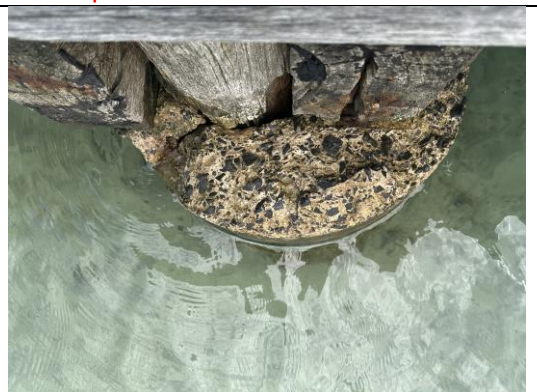
P4 Concrete Pot – extensive cracking & breakup

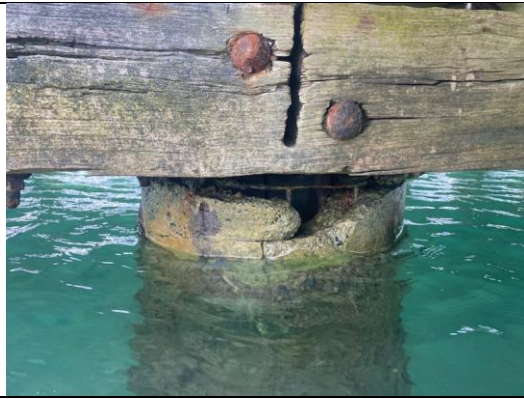
P5 Concrete Pot – extensive cracking & breakup with exposed steel reinforcement

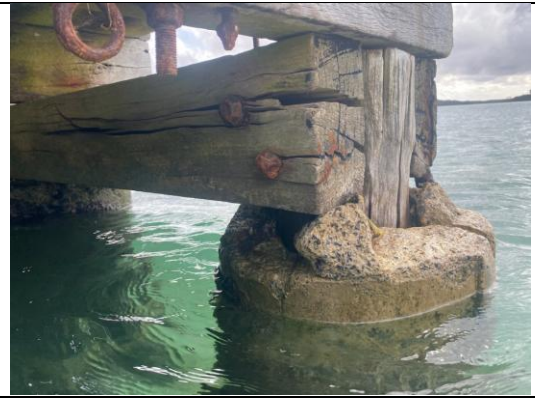
P6 Concrete Pot – extensive cracking & breakup

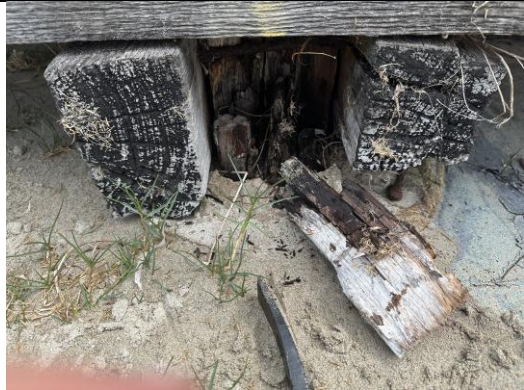
P7 Timber Pile – 30 to 40% loss in section due to rot

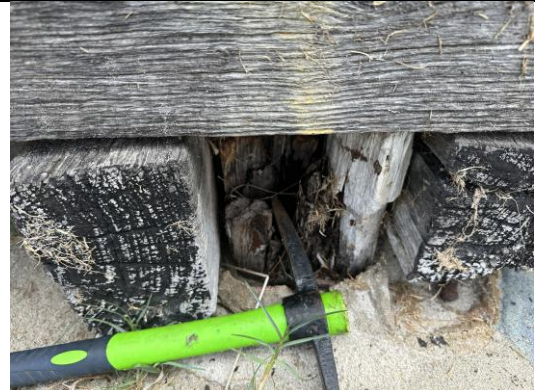
P8 Timber Pile – 30 to 40% loss in section due to rot

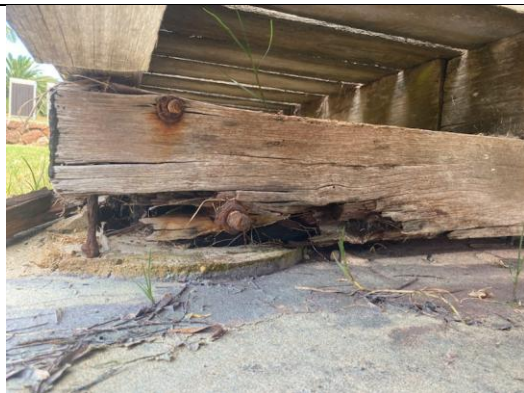
P9 Headstock – severely rotted

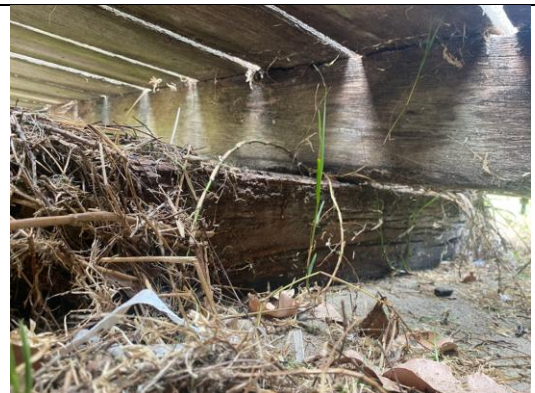
P10 Headstock – severely rotted

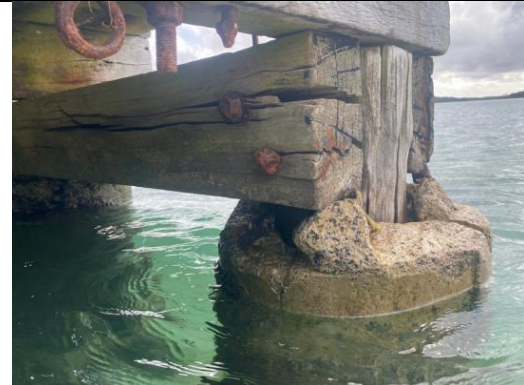
P11 Headstock – severe longitudinal split

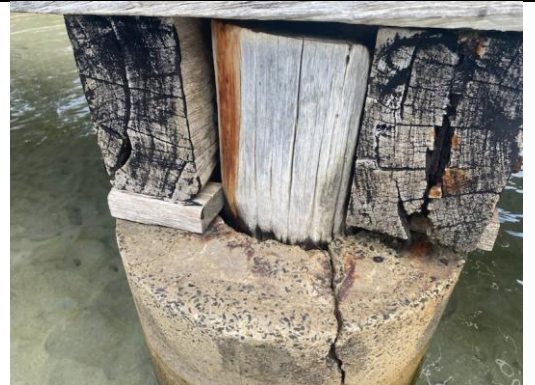
P12 Headstock – ends severely split

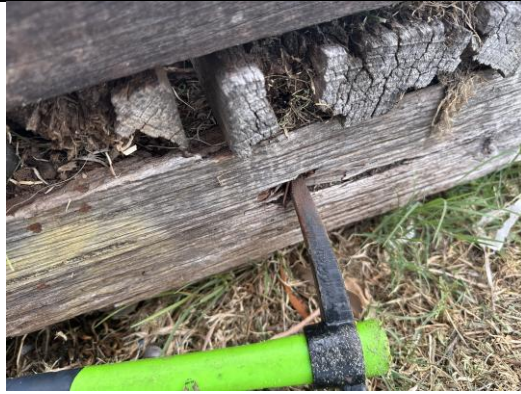
P11 Edge Bearer & Decking Ends – severely rotted

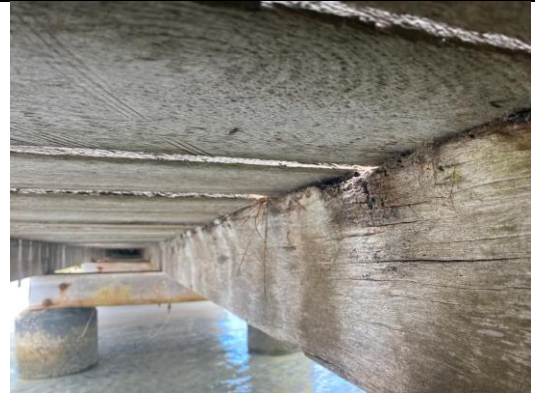
P12 Central Bearer – upper 30-50mm severely rotted

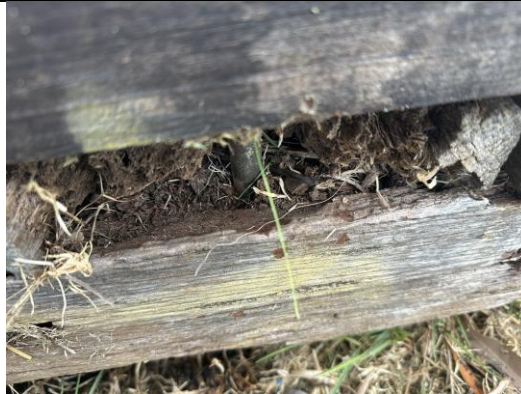
P13 Decking Planks – ends severely rotted

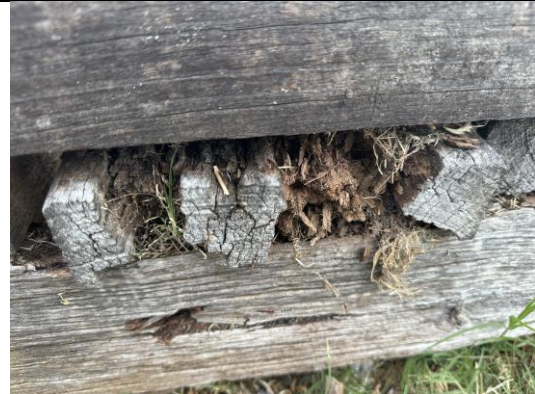
P14 Decking Planks – ends severely rotted

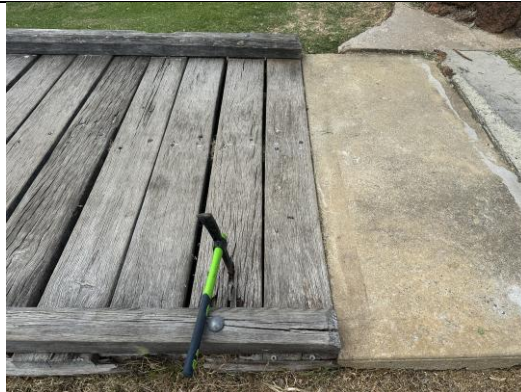
P15 Decking Planks – severely rotted

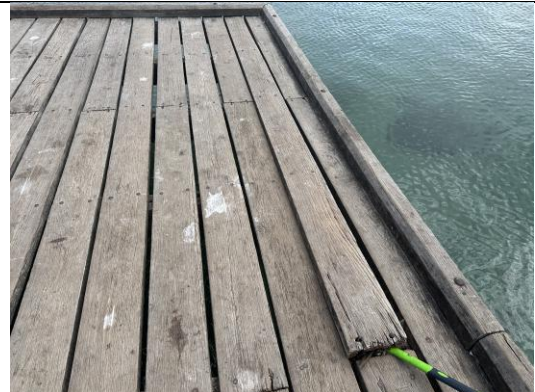
P16 Decking Planks – severely rotted
