**R2069 Rev 0**

**May 2025**

**Shire of Augusta Margaret River**

**Turner Street Jetty Replacement  
Concept Report**

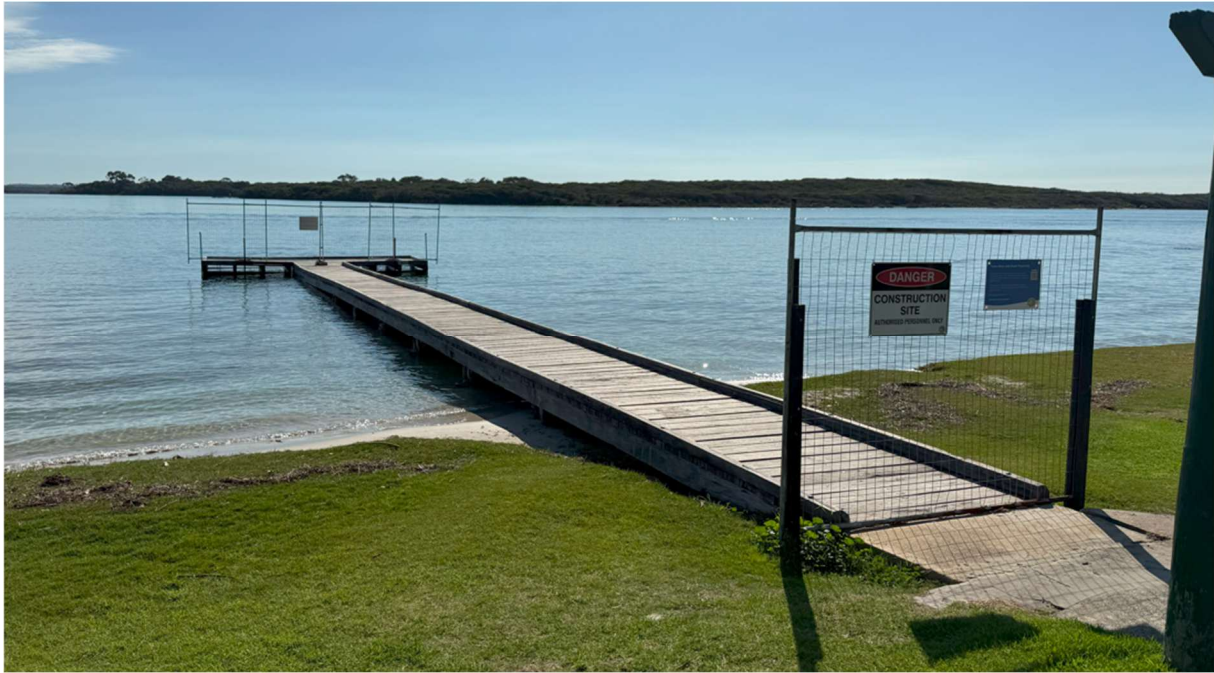
**Figure 2.1 Turner Street Jetty (May 2025)**

- The timber deck generally appears in an average to poor condition, with splits and section loss visible.
- The timber half-cap and joists appear to generally be in an average condition through most of their length, but with notable splits, deterioration and section loss evident at the ends.
- The timber piles were not fully visible at the time of the inspection. However, the visible portion appears to be consistent with the findings of previous condition assessments.

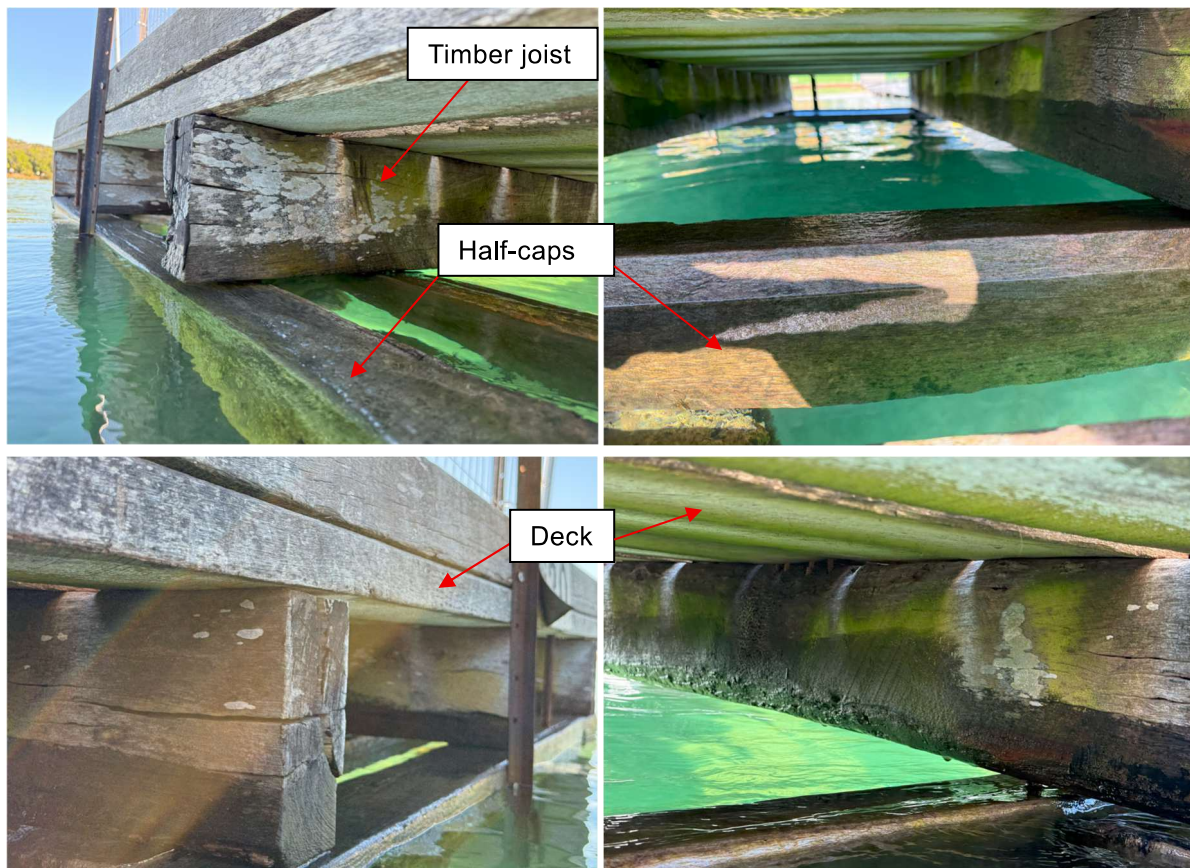
**Figure 2.2 Typical Photos of the Visible Jetty Elements**

The substructure elements are generally in an average condition. Although not all elements would need to be replaced, access to repair/replace deteriorated elements such as joists, half-caps and piles would require the majority of the substructure to be removed to provide access.

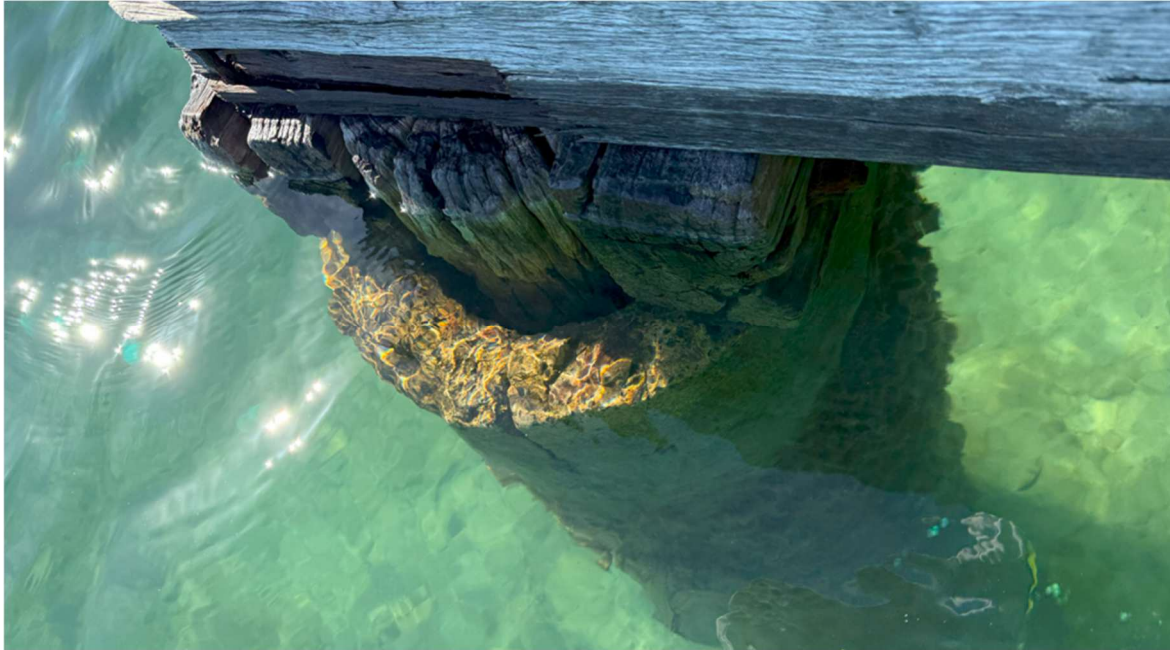
**Figure 2.3 Typical Photos of the Concrete Encased Timber Pile**

The existing pile foundation consists of timber piles encased with concrete. Evidence of cracking was noted on site, consistent with outcome of previous condition assessment undertaken by the Shire.

Repair of concrete encased timber piles is likely to be difficult, as removal of the existing concrete encasement may be required. The removal of the concrete encasement could further undermine the structural integrity of the jetty during the repair and significant temporary support works may be required.

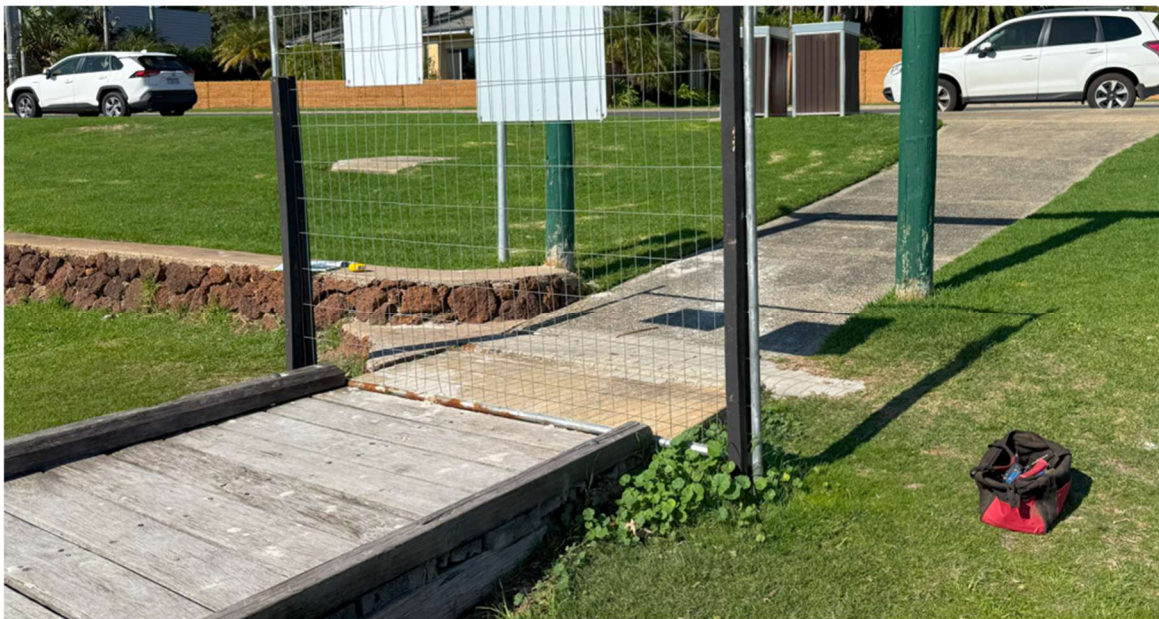
**Figure 2.4 Jetty Abutment & Land Approach**

The jetty abutment currently ties into an existing rock wall and a concrete footpath. Based on site discussions with the Shire, it is agreed that any jetty replacement option should consider locating the new abutment behind the existing rock wall to minimise any risk of undermining as a result of potential foreshore movement over the design life of the new jetty.

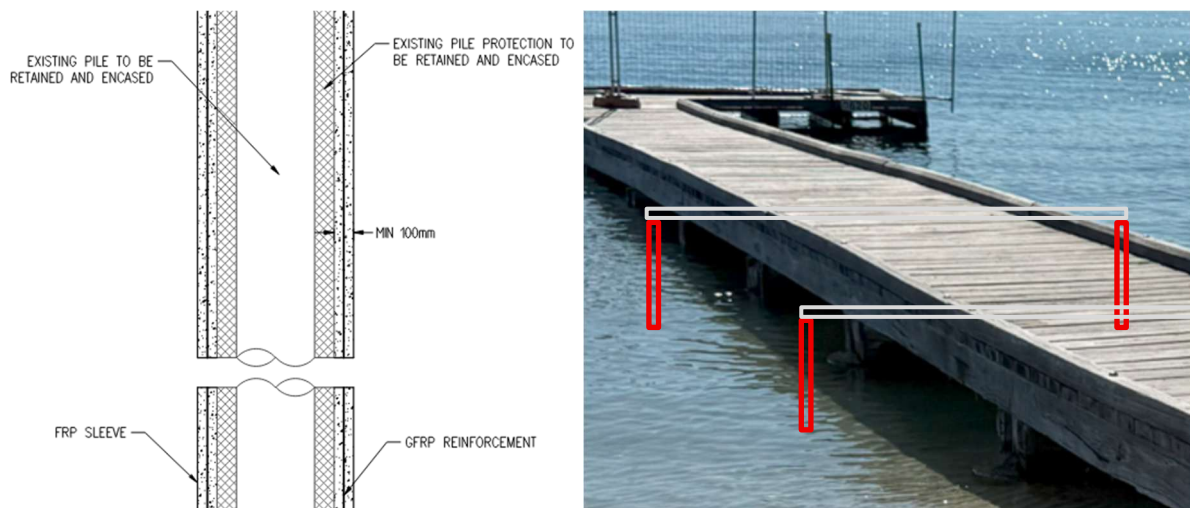
**Figure 3.1 Left: Repair to existing; Right: New piles installed at offset location**

Both types of pile repairs are temporary measures to slow down the ongoing deterioration. They do not necessarily improve the current condition of the piles.

- Repair of the concrete encasement. This could consist of the following.
  - Removal and replacement of the existing concrete encasement. This would keep a similar footprint and visual appearance as the existing, but likely to be difficult and risky to undertake.
  - Alternatively, construct a new encasement over the existing encasement.
- Installation of new pile at an offset location to the existing pile. This would involve installing new piles outside the footprint of the existing at offset locations and installing new support elements (joists and half-caps etc).
