## ASSET INVESTIGATION REPORT

### TURNER STREET JETTY (JETTY No. 0620), AUGUSTA

| 0 | Asset Investigation Report | D. Schlueter | R. Kelly | M. Gannon | 27/06/23 |

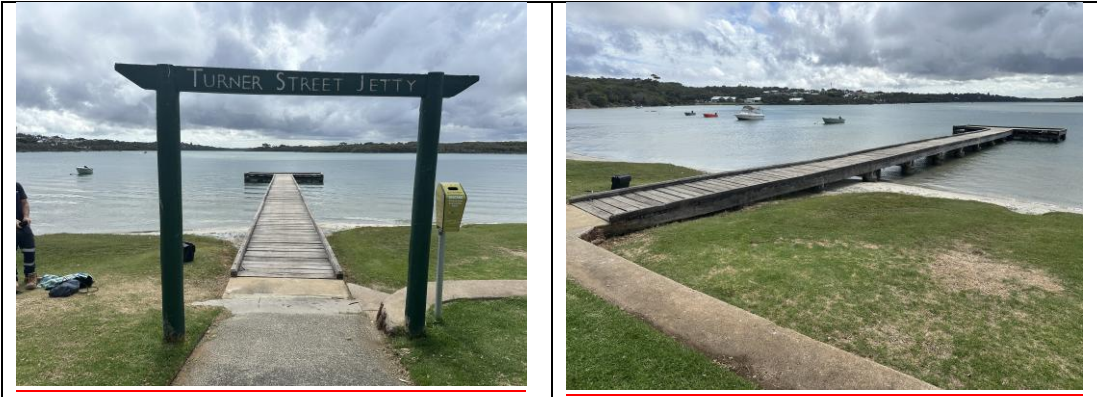
Joe Arena CPEng conducted a follow up site inspection on the 13/03/2025 of the Turner Street Jetty with photos taken and findings reflected in the following comments:

- 4) Since the previous inspection dated 27/06/2023, approximately 21 months ago, further degradation is evident throughout the Turner St. Jetty structure, namely – piles/concrete pots, headstocks, bearers and decking. Examples of the extent of degradation are presented below
